# One of the largest Oceanariums in Asia Improve Overall Tank Management with DPA System

Inhibit substrate growth and improve living conditions of Sea Dragon

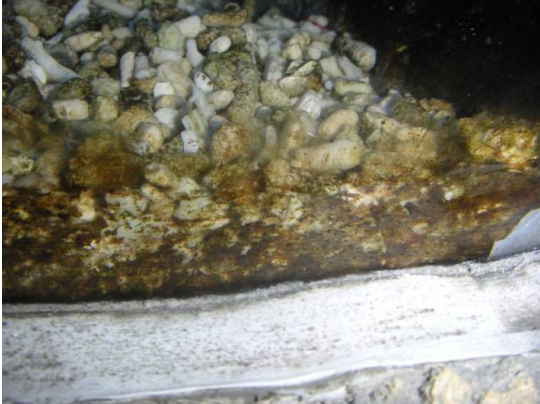
Figure 1: Picture taken on 14 November 2006. Typical sludge buildup in the Sea Dragon display tank after 6 months of usage.

From the oceanarium's historical records, it would usually have taken 2 months for substrate to be visible. However, after DPA system was installed, it has been close to 6 months but no significant substrate buildup has been observed in the tank. For instance, figure 2 shows the state of the tank on 14 November 2007, with heavy buildup of substrate at the bottom. Subsequently, the tank was given an overhaul and installed with the DPA system on 20 November. Figure 2 shows

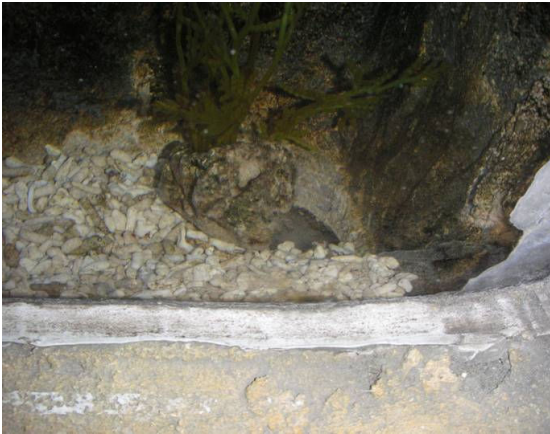
Figure 2: Photos was taken on 20 July 2007. No sign of sludge build up and substrate build-up under control

that the tank was not plagued by substrate problems even after 6 months.
